SURVEY ON ENVIRONMENTAL IMPACT OF CARBONATION PROGRESS AND REBAR CORROSION IN ACTUAL CONCRETE STRUCTURE

Takeshi IYODA¹ and Satoshi Maehara²

¹ Department of Civil Engineering, Shibaura Institute of Technology, Japan ² Tokyu Construction Co, L.t.d, Japan

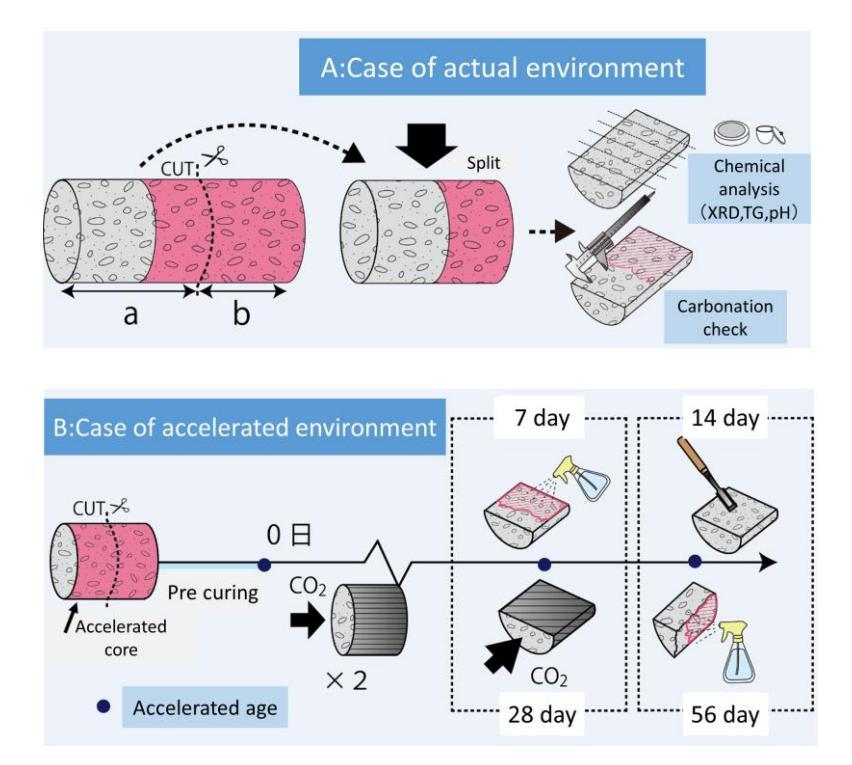
Figure 1: Core sample preparation for test

on this result, cutting samples were performed in the un-carbonated part as shown in Fig. 1, and it was divided into a real environment sample and an accelerated environment sample. After splitting cores, the real environment sample was measured, carbonation depth on one side and chemical analysis on the other side. The carbonation depth was determined by measuring the measurement result after 24 hours after 1% phenolphthalein solution was sprayed and the change in the coloration range settled down.

The test was conducted according to JIS A 1153. Fig. 1 shows the accelerated carbonation test method. The accelerating sample was cut into two parts by a wet method. A pre-curing was allowed to stand at constant environment on temperature as 20 degree Celsius and a humidity as 60% RH. After completion of the pre-curing, the surface excluding the cut surface was sealed, accelerated carbonation test was carried out with one surface open at 20 degree Celsius and humidity of 60% RH and carbon dioxide concentration of 5.0%. The carbonation depth was measured at 7, 14, 28 and 56 days after the started accelerated.

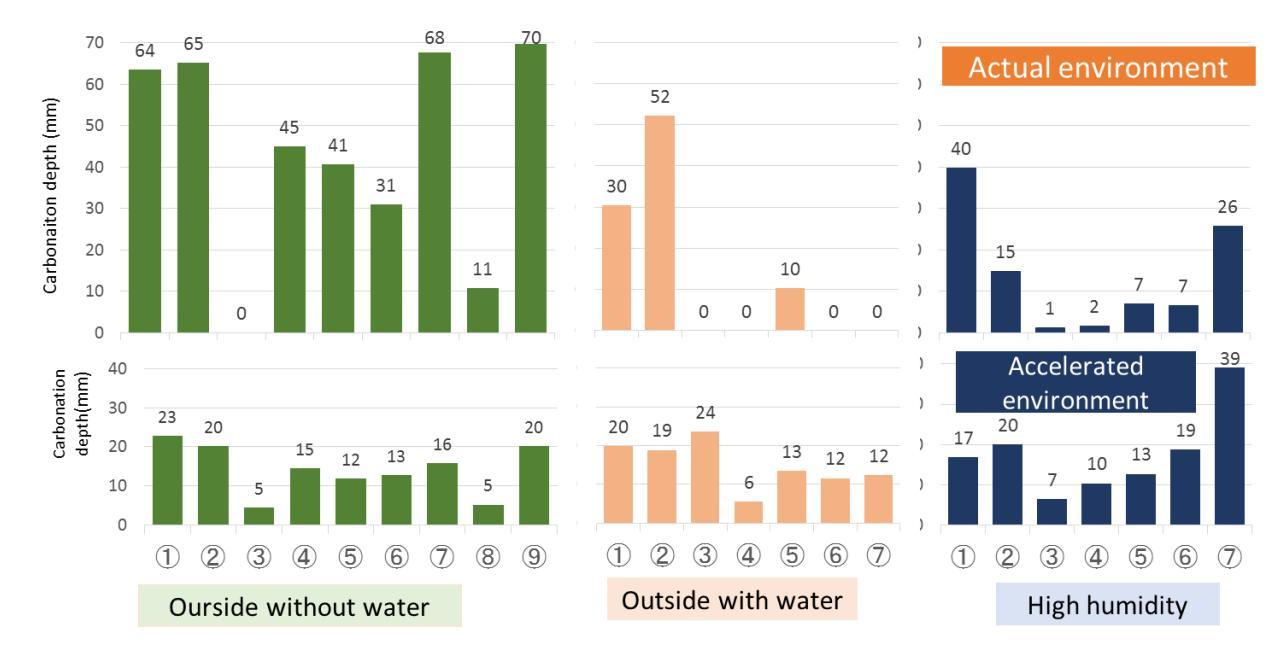
Figure 2: Results for carbonation depth in actual and accelerated environment on each cores

The upper part of Fig. 2 shows the measurement results of carbonation depth for each environmental condition. As environmental conditions, the carbonation depth is larger in outside without moisture, outside with moisture and high humidity environment. This indicates that the progress of carbonation is faster as the larger degree of drying. However, there are also places where there are almost no carbonation progression in outside without water near the dry state, and

where carbonation progresses fast in a wet state, high humidity environment. These are presumed to have influences other than the environment such as the difference depending on the part even in a place with rain, and the presence or absence of surface coating or finish. Next, the lower part of Fig. 2 shows the accelerated carbonation depth at 56 days. The carbonation depth of many cores was about 20 mm, however cores with early progress of carbonation and slow cores also existed. Thus, also in the potential of concrete itself, there is a difference in the progress of carbonation due to the influence of construction methods and using materials. Since this time using concrete inside the structure, it is considered the influence of cement hydration heat.

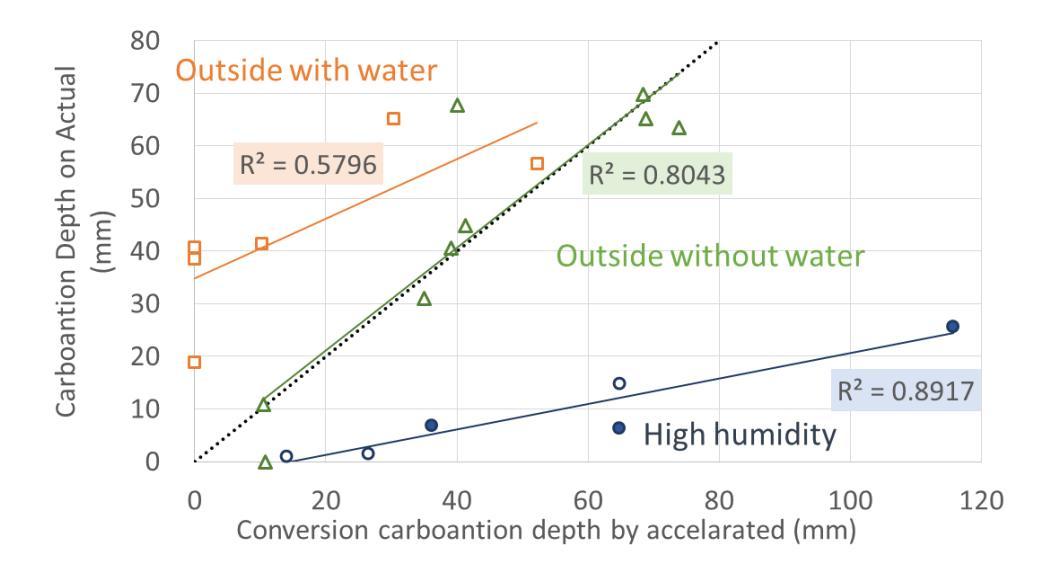
Figure 3: Compared with estimated and real carbonation depth

Fig. 3 shows the relationship between the estimated carbonation depth obtained using equation (1) and the carbonation depth of the real environment. The broken line in the graph indicates that the carbonation depth in the real environment is the same as the estimated carbonation depth from accelerated results. In the outside with water and high humidity environment, the easier it is to carbonate in the accelerated environment, the more carbonated it is in the real environment. Conversely, those which are not easily carbonated as the potential of concrete, the progress of carbonation was slow even in the real environment. However, in the environment on outside with rain, there was no correlation between the real environment and the accelerated environment. This is thought to be the difference for rain, the degree of drying and wetness depending on the climate, the influence of the presence or absence of finish. Focusing at the slope of the lines, there is outside without rain, outside with rain and high humidity environment on the inclination of lines. The outside with rain has the largest slope of line, it is found that it is almost the same as the broken line. This indicates that the accelerating rate of carbonation in the environment in which the most carbonation tends to progress in the real environment. In a real environment, it can be said that carbonation is suppressed under environmental conditions that water such as rain and high humidity influence. However, there are places where finishing is applied to the data in this research, so further study is required in the future.

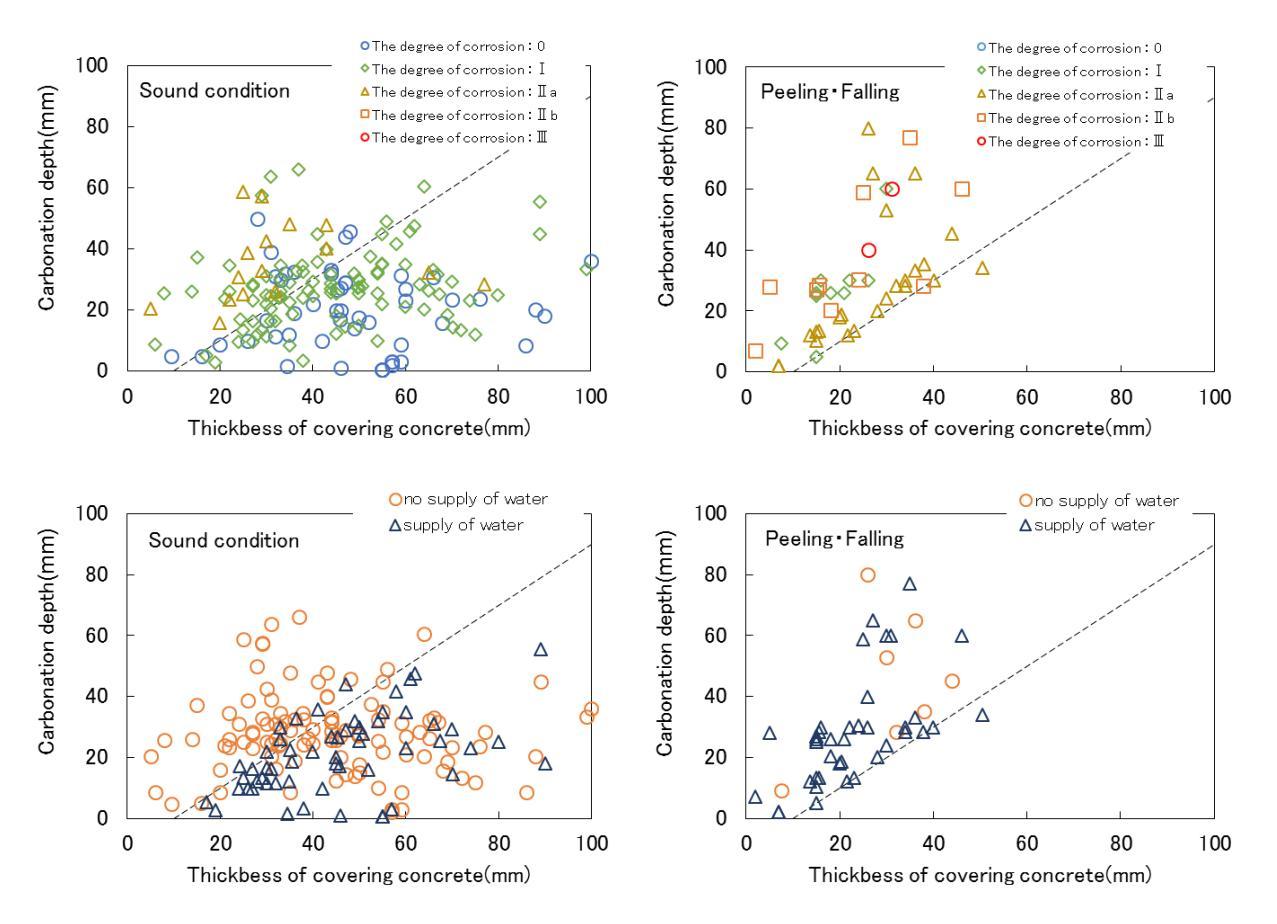
Figure 4: Relationship between thickness of covering concrete and carbonation depth

Figure 4 shows the relationship between thickness of cover concrete and carbonation depth. Fig. 4(a) shows the corrosion degree as classified, and (b) shows the influence of the presence or absence of water supply, are divided into the healthy part, the peeling and spalling part. The broken line in the figure shows the remaining 10 mm of carbonation depth, the stationary distribution on the left side of the broken line has the carbonation residue of 10 mm or less, and the rusting shown in the Concrete Standard Specification of the Japan Society of Civil Engineers carbonation beyond the limit is progressing.

According to Fig. 4(a), those with a degree of corrosion of II a or more of the reinforcing bars occurred where the remaining carbonation depth was approximately 10 mm or less. However, even with corrosion degree IIa, there were also scattered parts that did not lead to peeling and spalling of covering concrete. According to Fig. 4(b), when comparing the influence of water supply or not, there were many places where peeling and spalling did not occur in the case of without water supply. From the above results, it was shown that there was a tendency that peeling and spalling did not occur even if the degree of corrosion of the reinforcing bar was II a, if there was without water supply.

Upper: (a) focusing on the degree of corrosion, lower: (b) focusing on water supply

In the place where there is without water supply, it is understood that even if the carbonation depth exceeds the remaining carbonation depth 10 mm, the covering concrete does not often peeling and spalling. In addition, it can be inferred that when the covering concrete is about 40 mm or more, there are many cases where peeling and spalling does not occur.
